## PLUMBING DIAGRAMMS

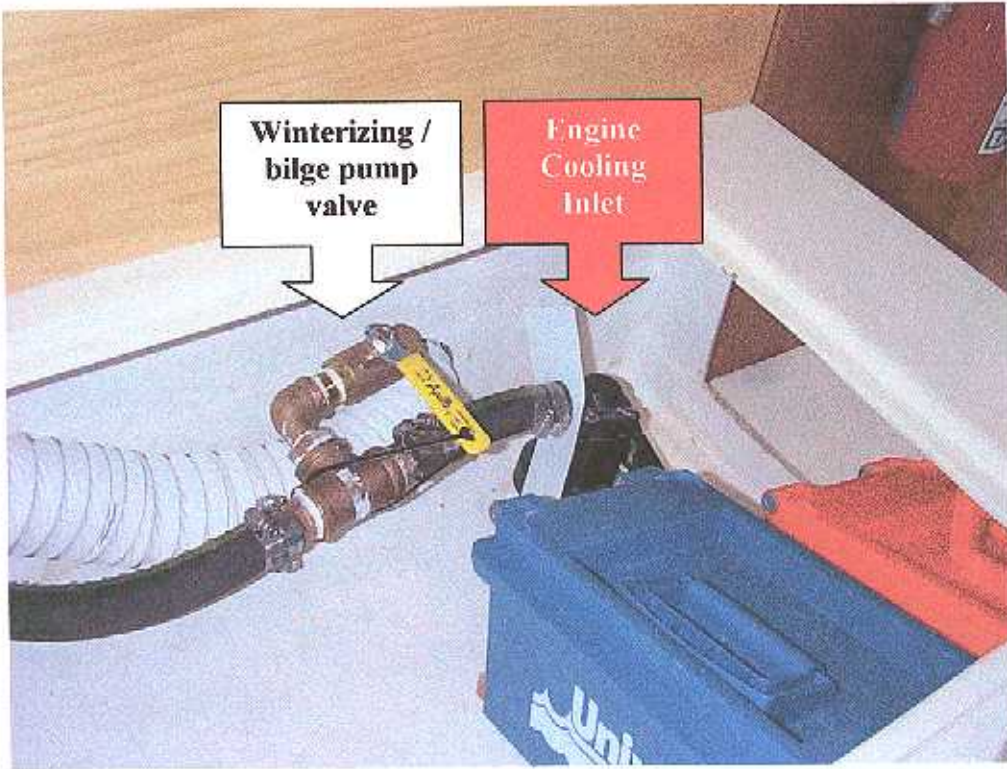
Fig 2.1 Engine Cooling inlet and winterizing/bilge pump valve

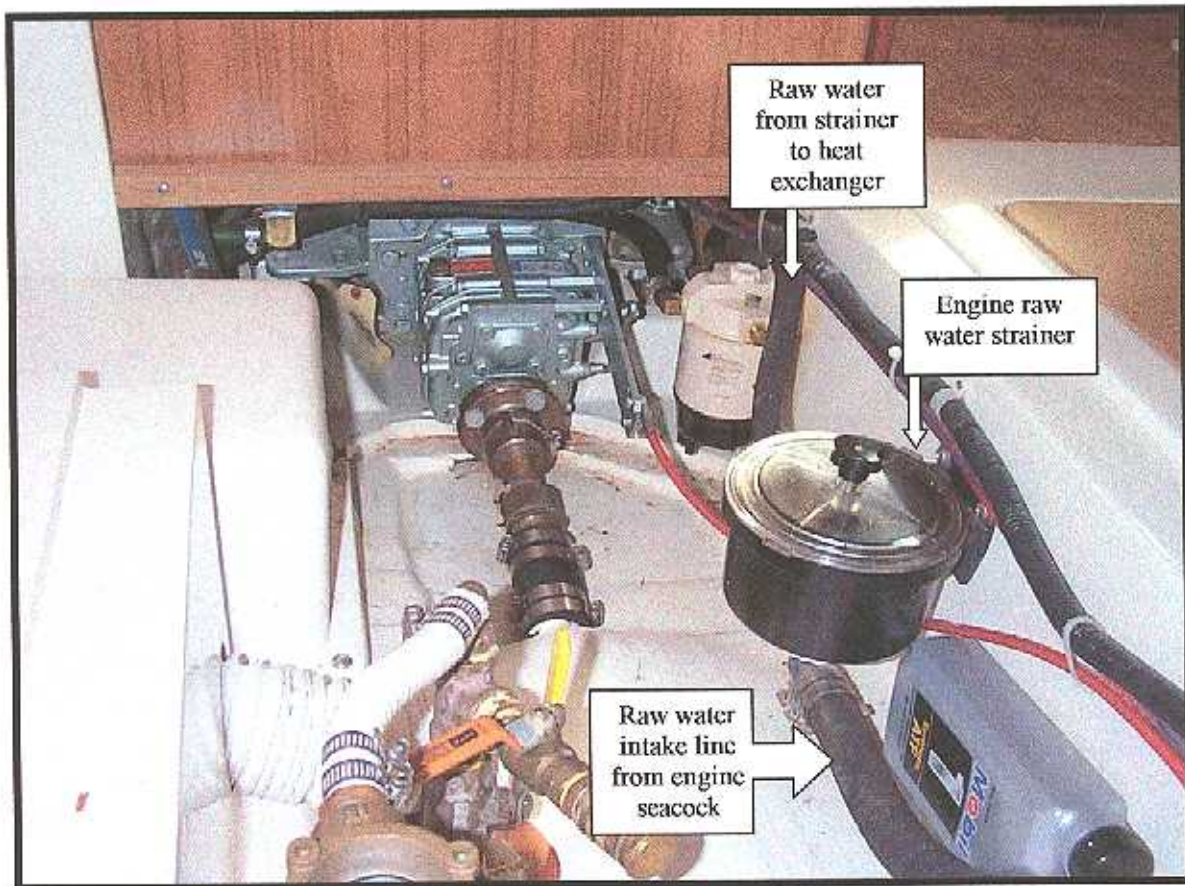
Figure 2.2 Raw water strainer. Aft Cabin - Picture taken from stern looking toward the engine

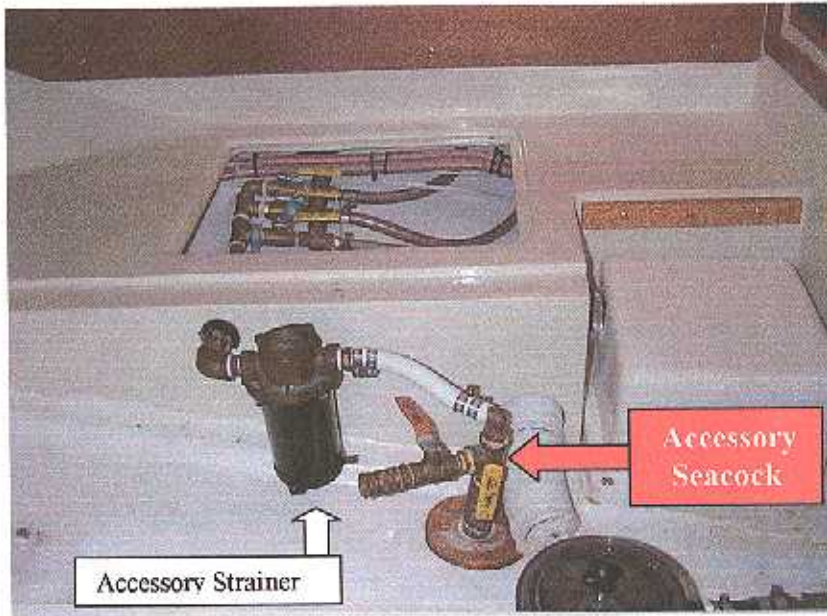
Fig 2.4 Accessory seawater intake system

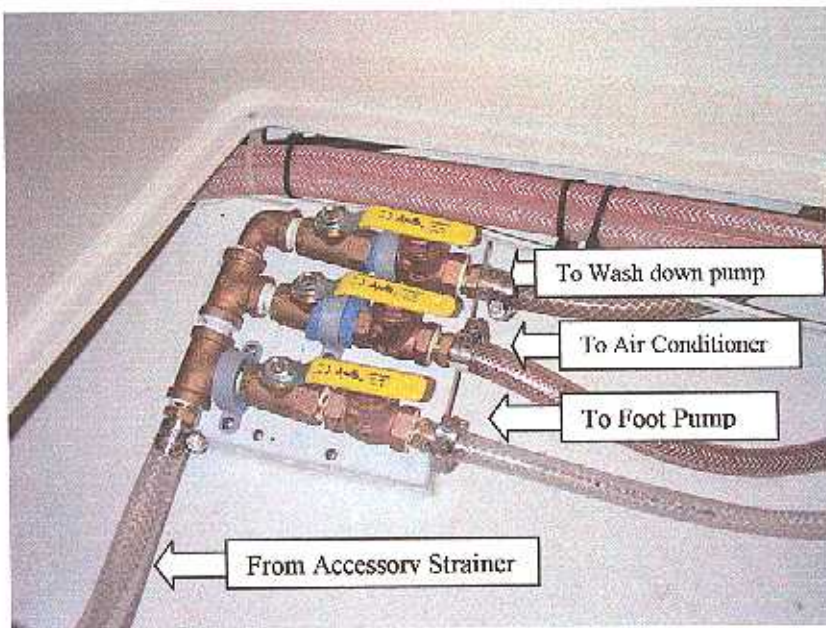
Fig 2.5 Accessory seawater manifold

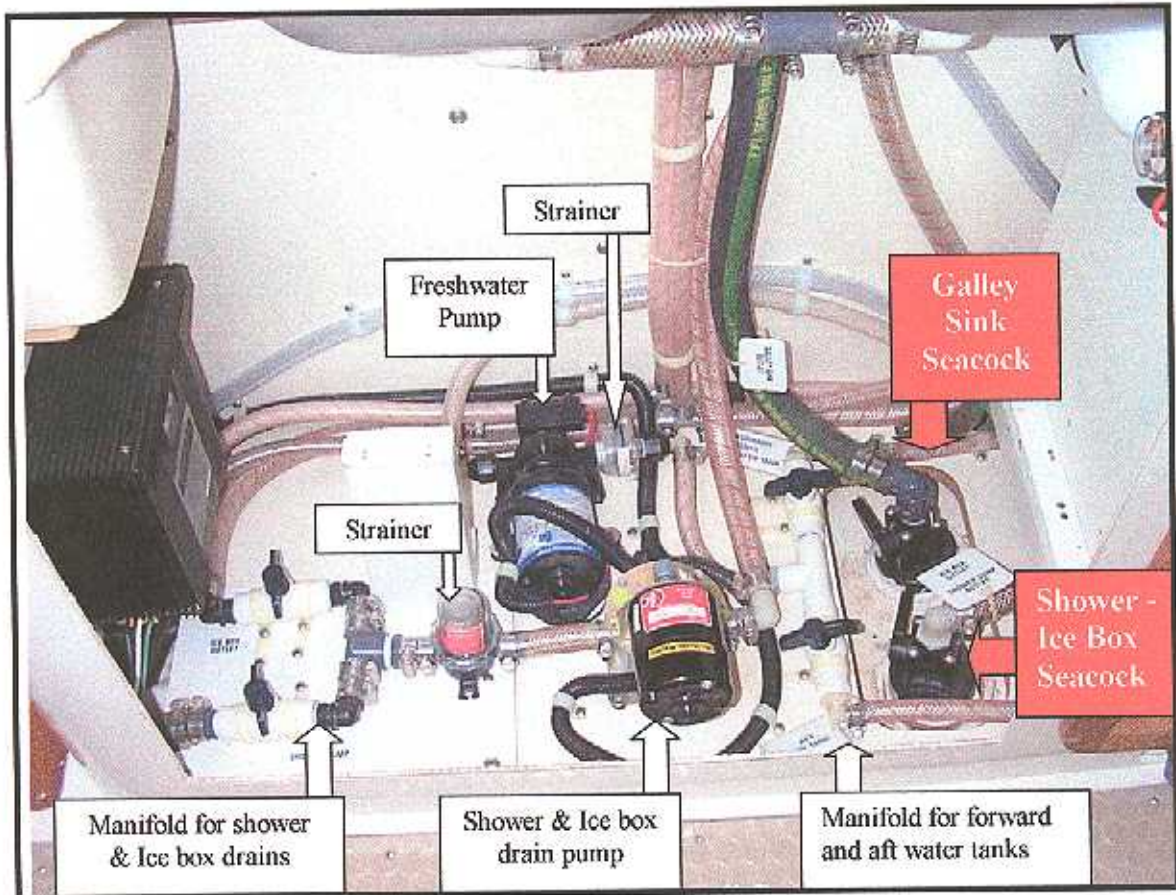
Figure 2.8 Potable water system – equipment mounted in the cabinet under the galley sink (photo taken from aft cabin looking forward – cabinet doors and horizontal shelf removed for picture)

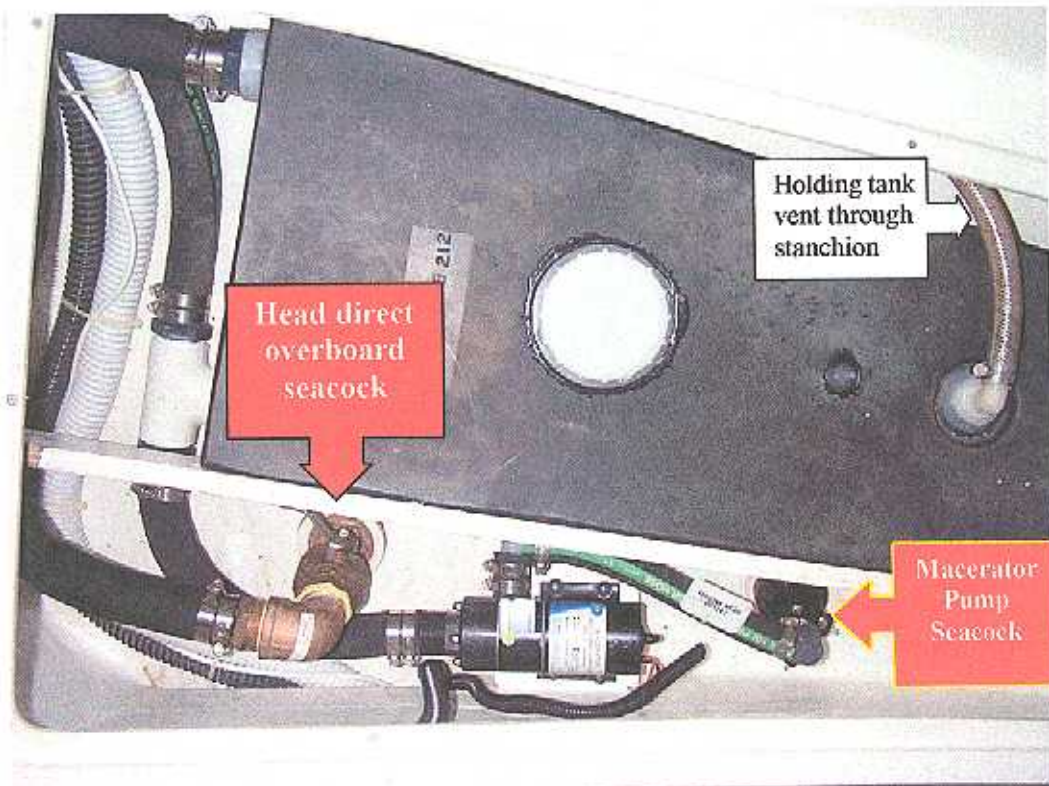
Figure 2.8 Holding tank, Head direct overboard discharge, Macerator pump and seacock.
